Case Study 10

**Newaukum River,
Lewis County, Washington**

Newaukum River, Lewis County, Washington

By Leland M. Saele, P.E., U.S. Department of Agriculture (USDA), Natural Resources Conservation Service (NRCS), Fort Worth, Texas; Dean M. Renner, P.E., USDA NRCS, Olympia, Washington; Molly E. Smith, USDA NRCS, Chehalis, Washington

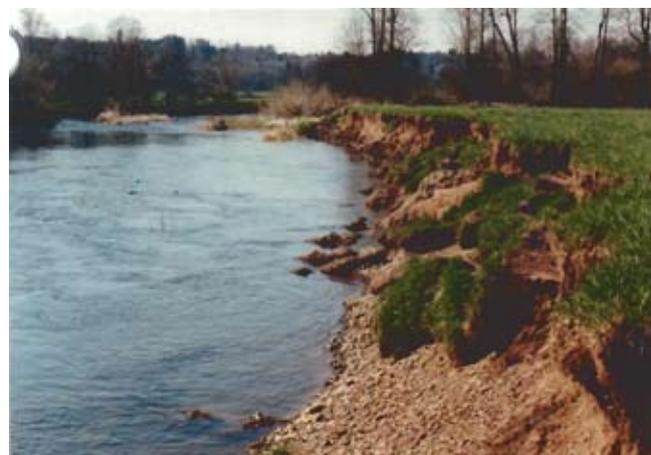
The ratios of radius of curve to channel width varied from <2 to 20, a nearly straight reach. The oversteepened bank slopes, combined with saturated soils, resulted in active bank sloughing during and following winter and spring high water events. These sites were not fenced prior to the project and were subject to livestock grazing.

Figure CS10–1 Typical conditions that existed at the project sites prior to design treatments

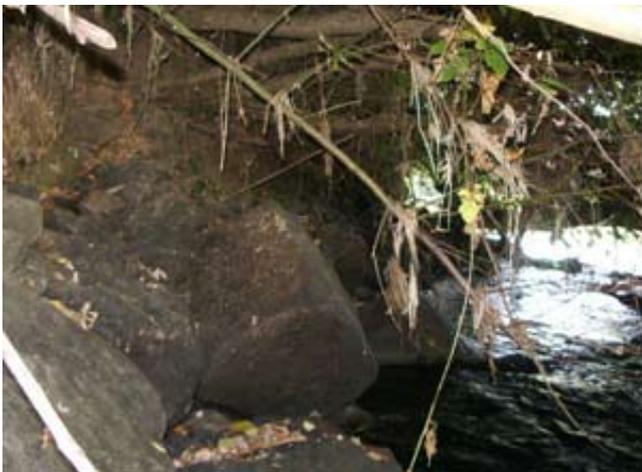
Figure CS10-4 Willow growth at RB structure

(a) Shading effect of willows

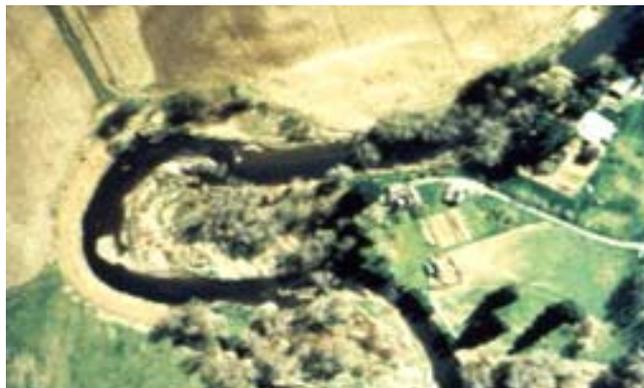
Figure CS10-5 Teitzel site

The Teitzel site, with the lowest R:W ratio, was initially treated with narrow (approximately 12-in-wide) rock and brush (RB) structures at 8- to 10-foot intervals. These failed in the first season during an over-bank flood event. Following the flood, the bank was reshaped and treatments applied as indicated in table CS10-4. The live stakes produced an extensive stand of woody bank cover the first year after repair. This was followed by an extremely dry year and infestation of the willow borer, which killed off 80 to 90 percent of the willows. Natural recovery was further decimated by beaver activity in subsequent years. Currently, the bank is stable with heavy grass cover, but no woody vegetation (fig. CS10-5).

(a) 1992, aerial view

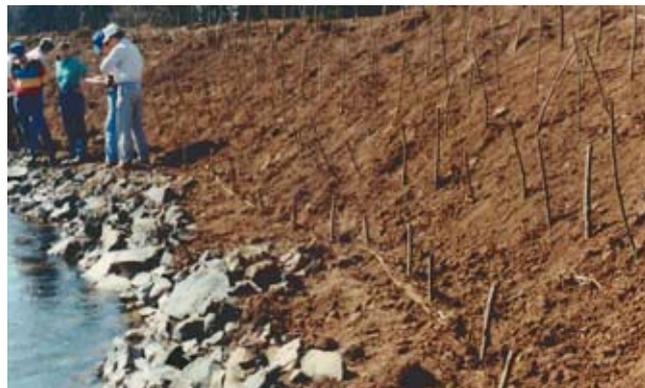
(b) 1992, after installation of live stakes. Note the fascine just above the toe rock.

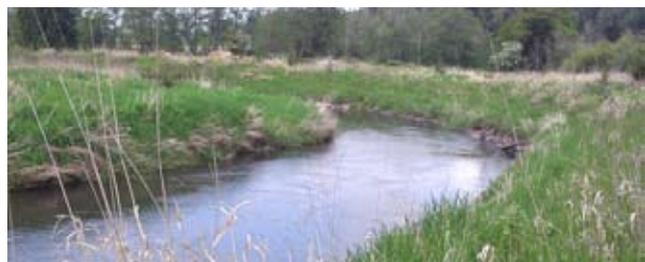
(d) 2005

Sometimes, even with proper maintenance, establishment of vegetative treatments can be difficult. The Teitzel site was also restaked after the willow borer infestation, but did not recover. Beaver activity and southern exposure at this site exacerbated the situation. In the fall of 2005, the banks were well grassed, but with no woody cover. It appears from table CS10-4 that soils and perhaps soil fertility have played a role at this site. Those sites with Chehalis silt loam soil series and south or east facing slopes did not fair well for establishment of woody vegetation.
