**Case Study 15**

**Streambank Stabilization in the  
Guadalupe River Basin,  
Santa Clara County, California**

*By John McCullah, Watershed Geologist,  
CPESC, and Kaila Dettman, Watershed Hydrologist  
of Salix Applied Earthcare*

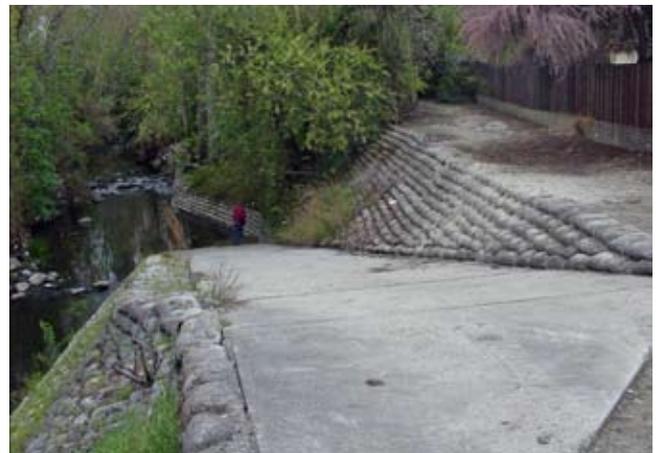
The original restoration work involved removing the damaged concrete access ramp and the sack concrete wall (fig. CS15-1) and replacing the structures with more habitat-friendly treatments. Restoration of the streambank included complete removal of the access ramp. Biotechnical techniques were installed on

**Figure CS15-1** Damaged access ramp and wall

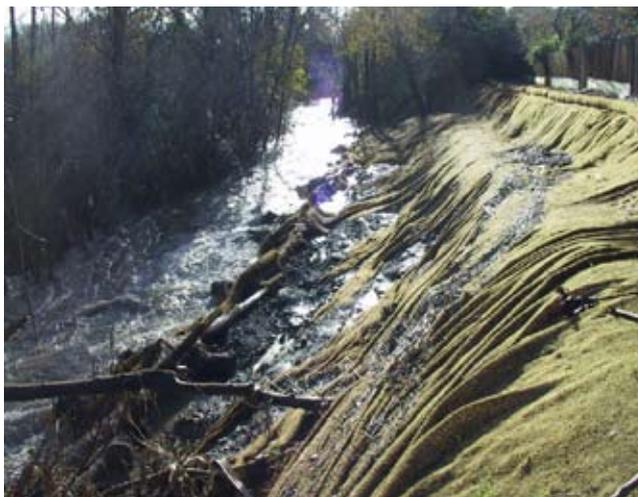
During December 2002, the first winter following project completion, a significant storm event occurred with a 5-year return frequency. The coir netting was severely damaged, and the underlying fill on the toe and midslope of the streambank was undercut and washed away (fig. CS15-3). The logs at the toe of the slope remained in place, yet extensive scour occurred around the structures (fig. CS15-4).

Hydraulic analysis indicated that the river reached velocities of 6 feet per second, developed shear forces of approximately 1 pound per square foot, and was at least 17 feet deep during the storm. The question was whether the failure was due to shear forces too great for the geotextile material or due to improper installation.

**Figure CS15-3** Damaged streambank following a 5-year frequency event in December 2002

The authors determined that the blankets had been installed incorrectly because the application had been applied based on the principles of slope stabilization, not channel stabilization. Channel installation requires that blankets be oriented parallel to the flow and include anchor slots (fig. CS15-7). Prior to coir

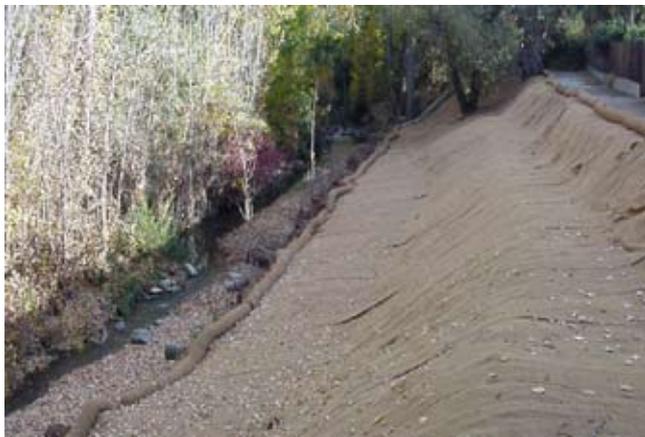
Installation proceeded as planned in fall of 2002 (fig. CS15-2). Log structures were keyed into the toe of the slope to provide anchoring and stability. Blankets made from coir netting ( $900 \text{ g/m}^2$ ) were laid out vertically along the slope (or perpendicular to the flow, which was consistent with manufacturer recommendations for slope protection), with coir rolls installed on the top and toe edges of the blanket layer. The blanket was then stapled along the length of each section.

**Figure CS15-2** Finished original project in fall of 2002

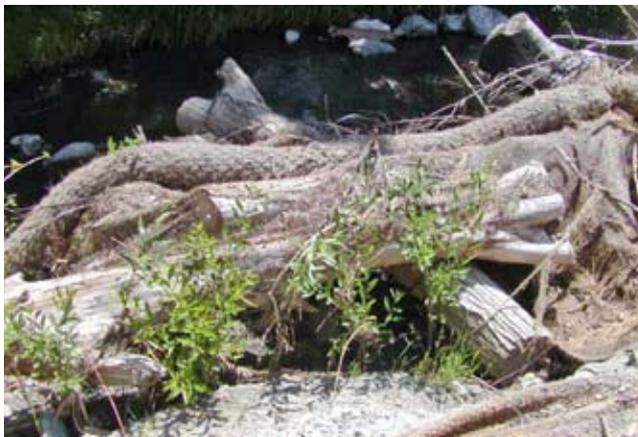
**Figure CS15-4** Evidence of scour and exposure of the log structures

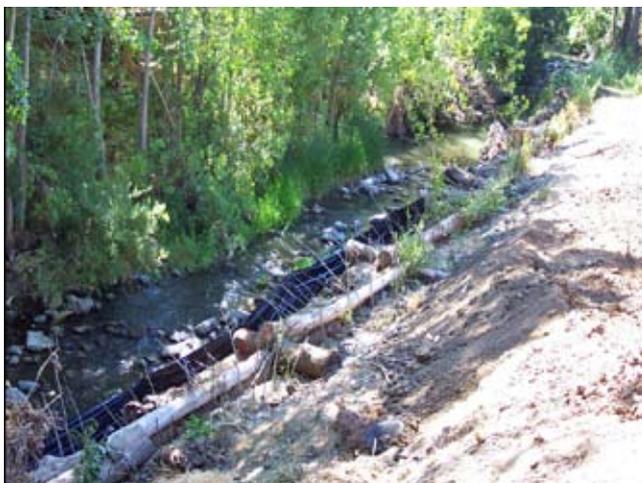
**Figure CS15-5** Live siltation installation

staked into the soil and rock above and within the log structures at the toe of the bank (fig. CS15-5). Deep, voided areas from the previous erosion allowed the stakes to be planted without digging. Willows are capable of withstanding periodic inundation and high velocity flows, and the roots help anchor the toe, while surface vegetation provides shading and habitat.

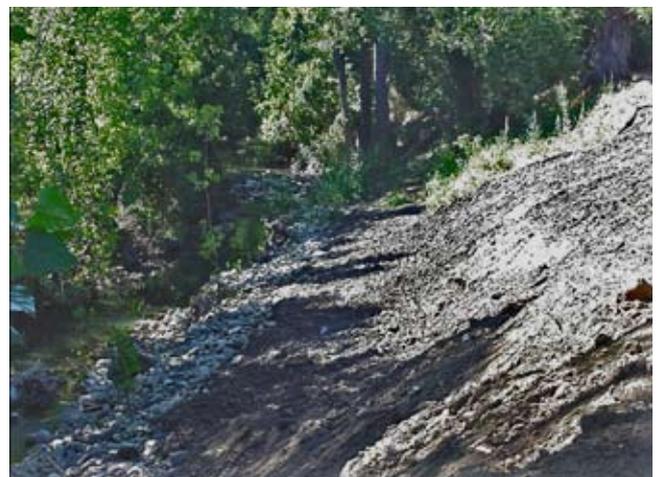
**Figure CS15-6** Cobble placement following the live siltation installation

The use of stone was prohibited due to new policies that allowed only “green” solutions within the watershed. The recommendation that cobble be installed was met with resistance; however, regulatory personnel were reassured that cobble would provide natural habitat and aesthetic value while improving channel integrity. Following the installation of the willows, cobble was placed on the toe of the slope to armor the bank and provide initial support for the willows during establishment (fig. CS15-6). Rounded cobble was used and fit in with the appearance of the river while providing the stability needed at the toe of the bank.

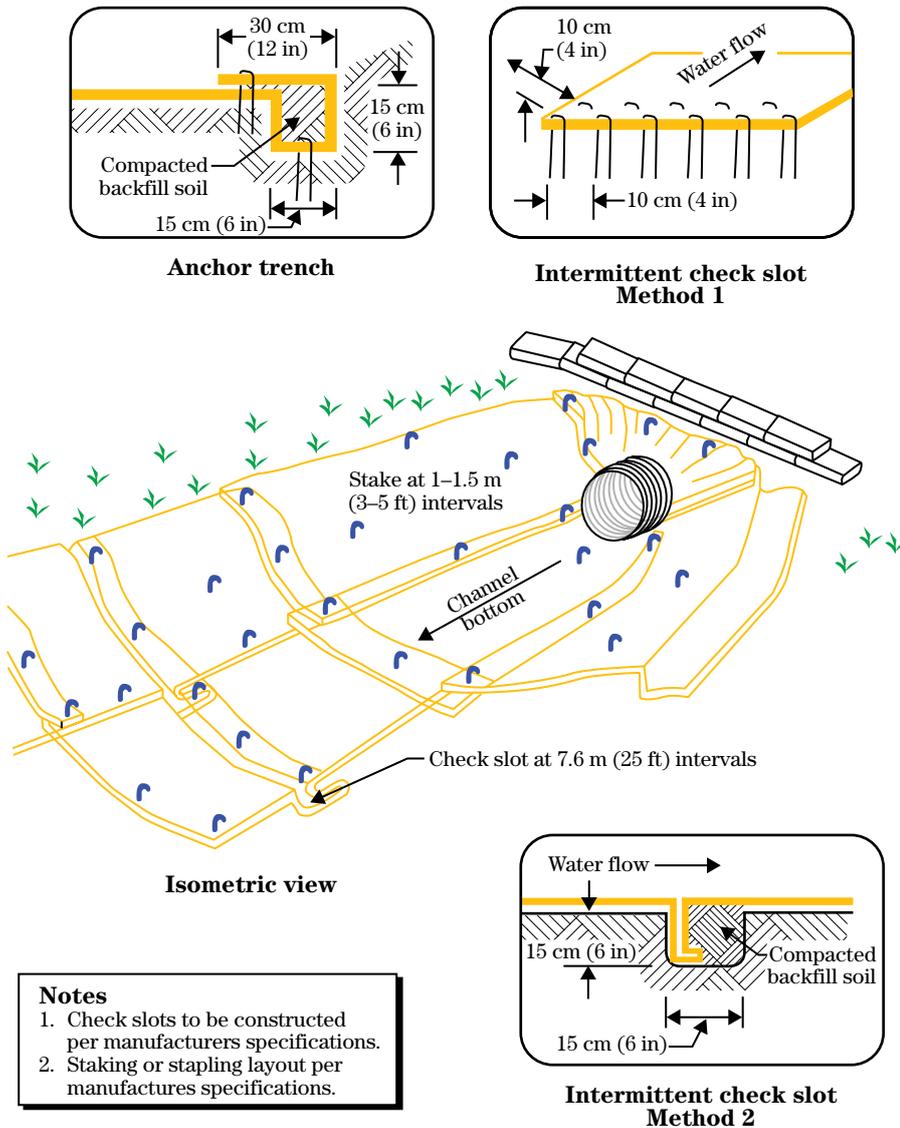
**Figure CS15-7** Erosion control blankets channel installation

blanket application, the slope was regraded, top soil was placed on terraces and compacted to 85 percent of optimum density, and mulch and seed were applied hydraulically to the slope. Longitudinal slots (horizontal) and check slots (vertical) were dug into the fill material on the middle and upper portions of the bank to serve as footings for anchoring the blankets and coir logs.

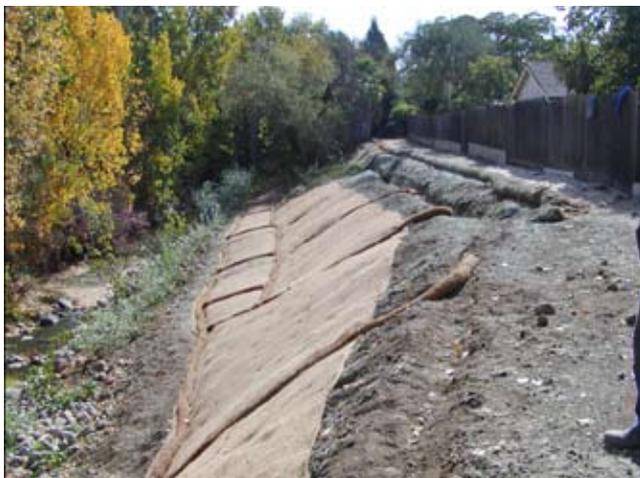
**Figure CS15-8** Slope preparation and blanket installation

Materials included 55 coir logs at 6 inches in diameter and 10 feet in length, 7 rolls of GEOCOIR®/DeKoWe® 900 geotextile blanket, and one 100 #3 rebar J-hook staples (with 18-in legs and 6-in hooks). The coir blankets were rated to withstand velocities of 10 feet per second by the manufacturer. The blankets were installed loosely to allow all fibers to make contact with the soil surface and were laid horizontally along the slope (parallel to the river) to reduce the potential for undermining and dislodging by high flows. The coir logs were installed over the blankets in the previously dug trenches and anchored with the hooked staples on both sides of the coir log. The edges of the blankets were incorporated into small trenches and backfilled to secure the material to the slope (fig. CS15-8). Additional cobble was brought in and incorporated on the toe of the slope following blanket installation, and the project was completed (fig. CS15-9). Container plants were installed later with DriWater™ packets to provide necessary moisture during the establishment period.

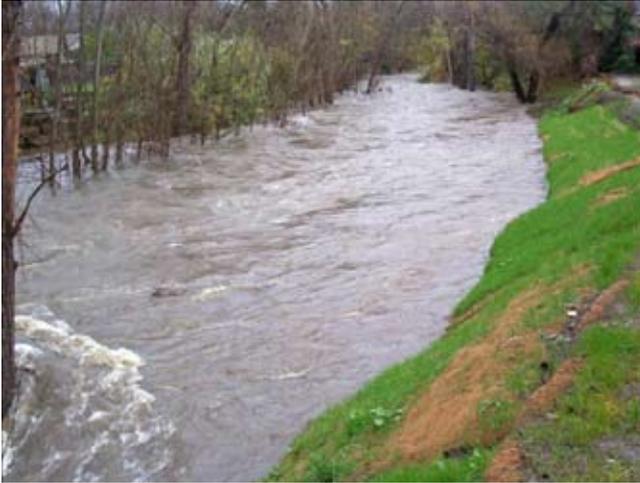
events demonstrated the inundation experienced by the slope during high flows (fig. CS15-10). Following a storm in January 2004, the flow line reached high elevations on the slope and indicated that the restoration work had been successful (fig. CS15-11).

**Figure CS15-10** Inundation of the restored slope

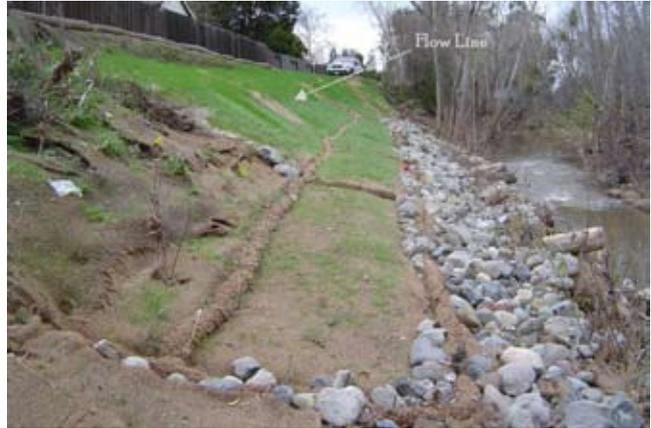
**Figure CS15-11** Flow line after a storm in January 2004

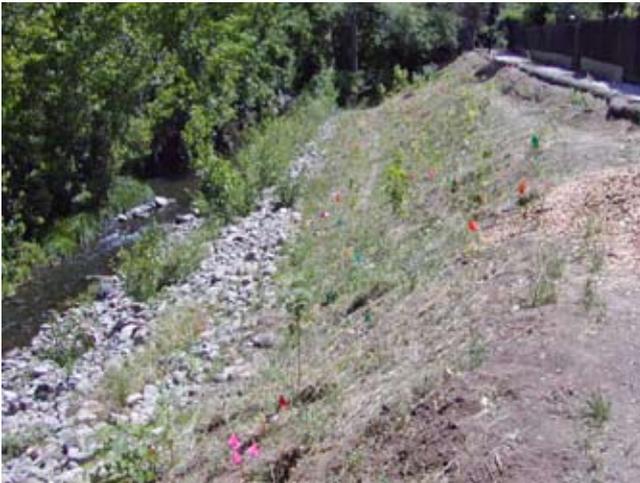
The restoration work performed in 2003 was extremely successful in stabilizing the slope. In April 2004, the bank was becoming vegetated (fig. CS15-12), and the willows were successfully established at the toe (fig. CS15-13). For future projects, plantings should be performed with minimal disturbance to the geotextile blanket (holes cut for the vegetation were quite large and could provide a potential point of undermining). The project emphasized the importance of installing geotextile blankets parallel to the flow of water within channels where inundation will occur. Combining techniques such as cobble revetment, live staking, pole planting, live siltation, hydroseeding, and coir blankets provided the stability, habitat, and aesthetic value needed for the site.

**Figure CS15-12** Revegetated slope 1 year later

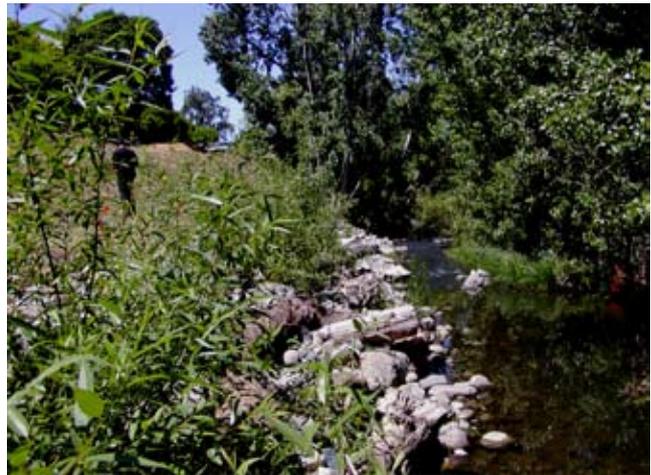
**Figure CS15-13** Willow establishment at the toe
