By Sean Welch, state hydraulic engineer, U.S. Department of Agriculture, Natural Resources Conservation Service, Portland, Oregon

Introduction

The Wiley Creek Streambank Protection Project in Linn County, Oregon, was designed in 2003 and 2004 by the U.S. Department of Agriculture (USDA) Natural Resources Conservation Service (NRCS), Oregon State Office. The project goals included the protection of two structures located 5 feet from the edge of a 23-foot-high vertical bank, bank stabilization, and fisheries habitat improvement.

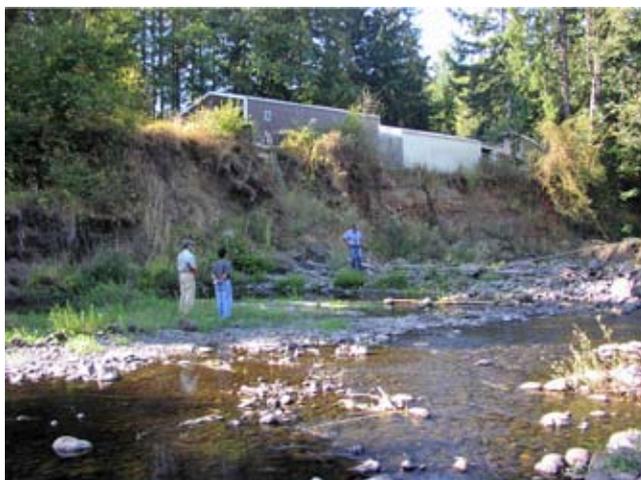
Figure CS18-1 Preproject riverbank along Wiley Creek, December 2003. Note location of buildings at the top of bank.

bank with two structures approximately 5 feet from the top edge of the bank (fig. CS18-1). Anecdotal information from the landowner and analysis of historical photographs indicated that the river's left bank had eroded more than 40 feet since the rain-on-snow flood event of 1996 (fig. CS18-3).

During the initial site reconnaissance, the bank condition was evaluated for both hydraulic and geotechnical stability. The bank had eroded to a near vertical condition and was well beyond the stable angle of repose (fig. CS18–9). Bank stratigraphy consisted of poorly consolidated alluvium (fig. CS18–10). The buildings at the top of bank were an additional destabilizing factor as point loads. The dominant bank failure mechanism was hydraulic stress undercutting the bank with subsequent tension-block failure of the overburden. Rapid drawdown of the saturated soils and positive pore water pressure within the bank also contributed to instability.

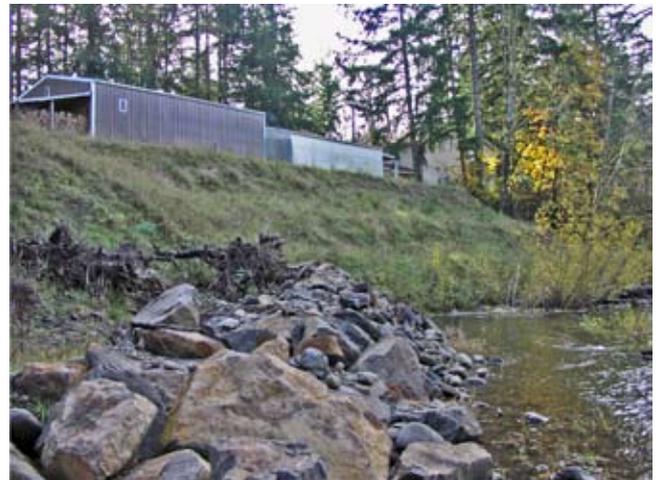
Figure CS18-2 Completed reinforced earth embankment, stream barb, and bank vegetation 1 year following construction

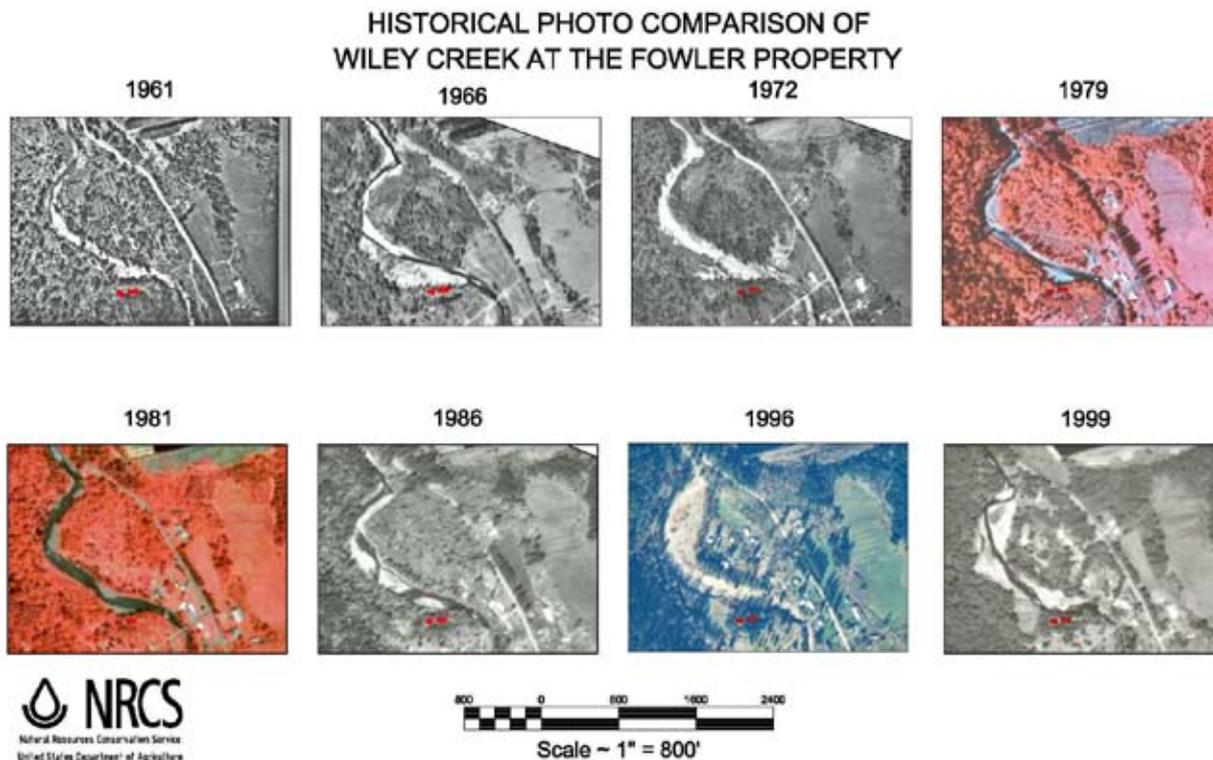
Figure CS18-3 Historical aerial photographs of Wiley Creek along the project reach showing morphologic changes over time

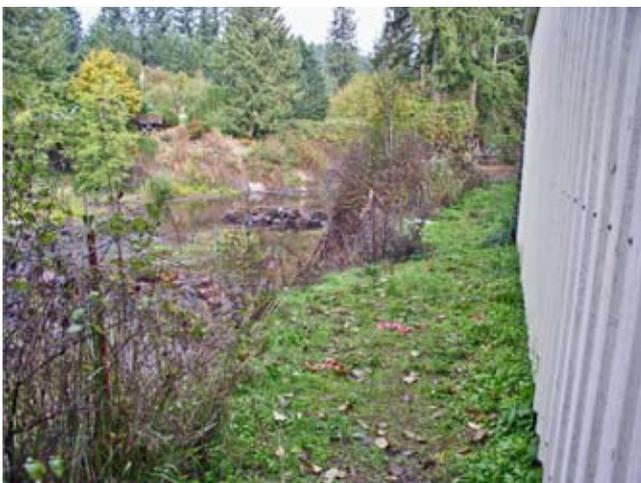
Figure CS18–9 Looking upstream at the project bank. Less than 5 feet of bank remained from the building to the edge.

The combination of hydraulic stress, low strength of the earth materials, and loading condition at the top of the bank required a design that would provide free-draining support to the bank, while resisting hydraulic stresses. Preliminary alternatives were identified that included an out-sloped embankment with a rock-reinforced toe or a structural fill section using cellular confinement or reinforced earth.

Reinforced earth combined with soil bioengineering techniques was chosen based on proven transportation applications, ease of permitting, and ability to

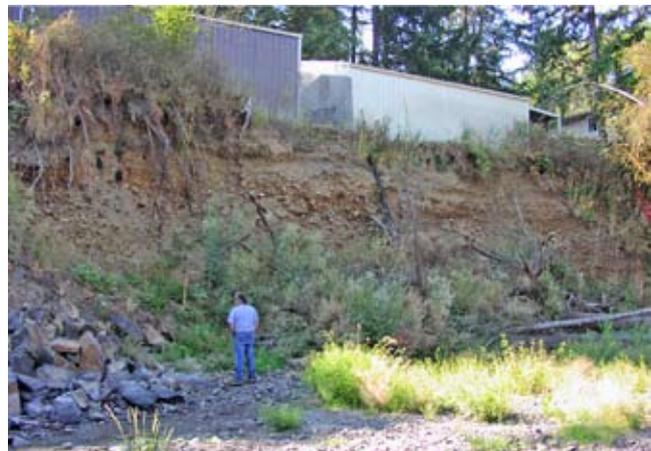
Figure CS18–10 Instream view of project bank. Note vertical condition and poorly consolidated sandy-silt alluvium bank material.

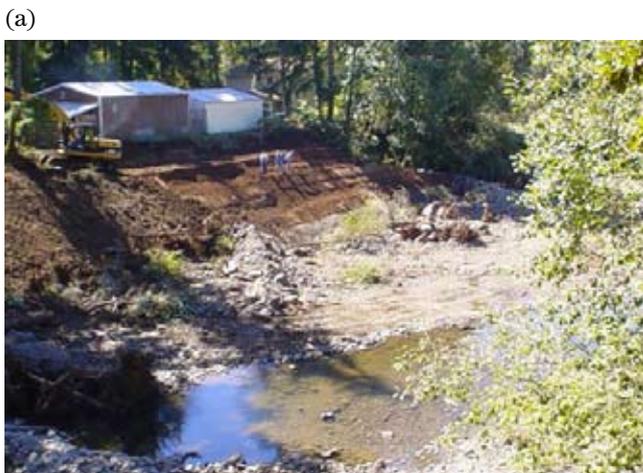
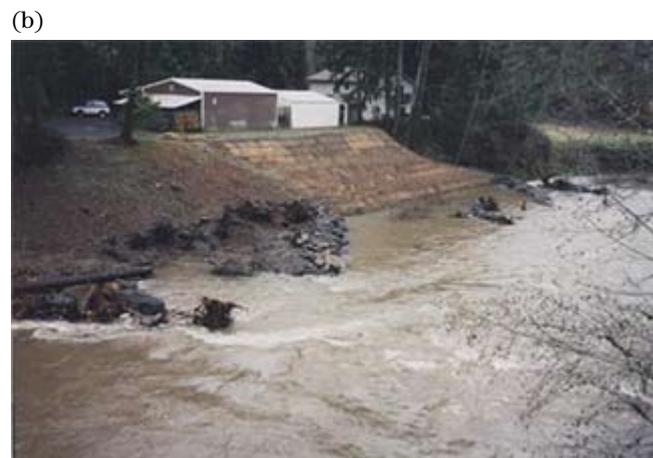
High flows tested the project after construction was completed in August 2004. A late December storm brought significant snowfall to the Cascades which rapidly melted during a warming trend. This snowmelt-driven runoff, combined with rainfall, resulted in considerable discharge in many of the Cascade River systems. The project experienced a flow of approximately 2,500 cubic feet per second without any erosion (fig. CS18–22). The revegetation and plantings were in a dormant condition and offered little benefit of hydraulic resistance, which served as a testament to the effectiveness of the ELJ and stream barb design incorporated into the project. Currently, the growth of the vegetation components, including willow cuttings used in the embankment and the clump plant-

Figure CS18–22 (a) Project nearing completion. All primary project components are complete except for embankment vegetation. (b) November 2004 flooding approximately 2 months after the completion of construction. Note high velocities deflected at the upstream log jam (on left of photo) and the subcritical, low-shear stress flow condition in the near bank region along the embankment toe.

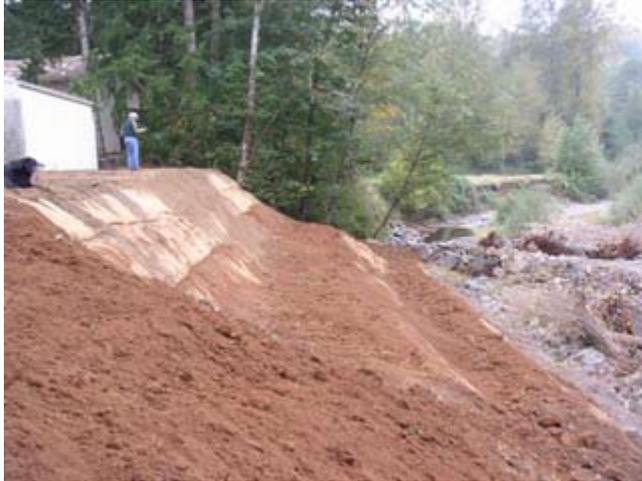
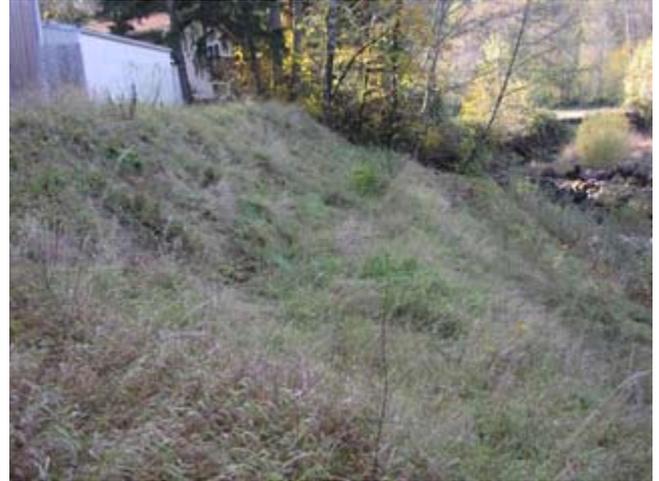
Figure CS18-23 (a) Looking downstream along the embankment immediately after construction and before planting of vegetation (August 2004); (b) Same view of project in December 2005 showing vegetation establishment. Note location of buildings in both photos.

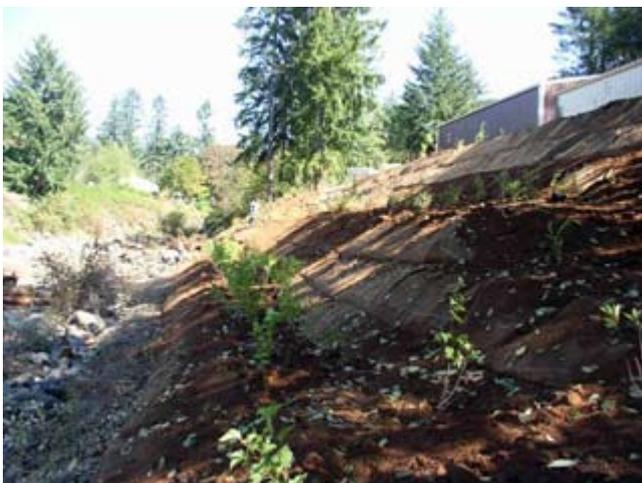
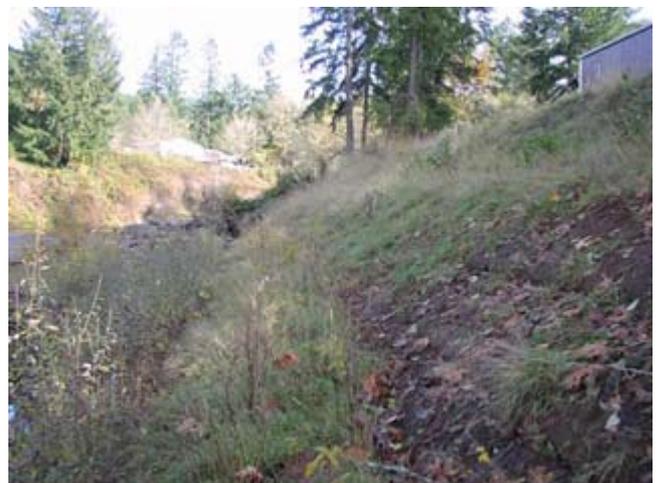
Figure CS18-24 (a) Looking upstream along the embankment immediately following placement of vegetation (August 2004); (b) Same view of project in December 2005 showing establishment of vegetation with vigorous willow growth along the embankment toe. Note location of buildings in both photos.

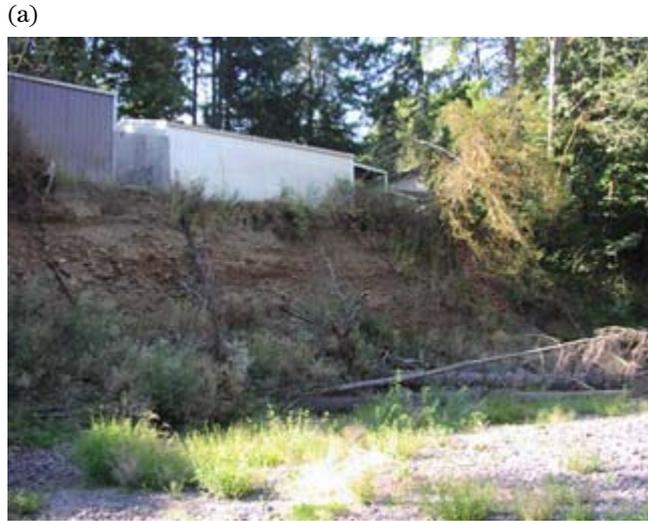
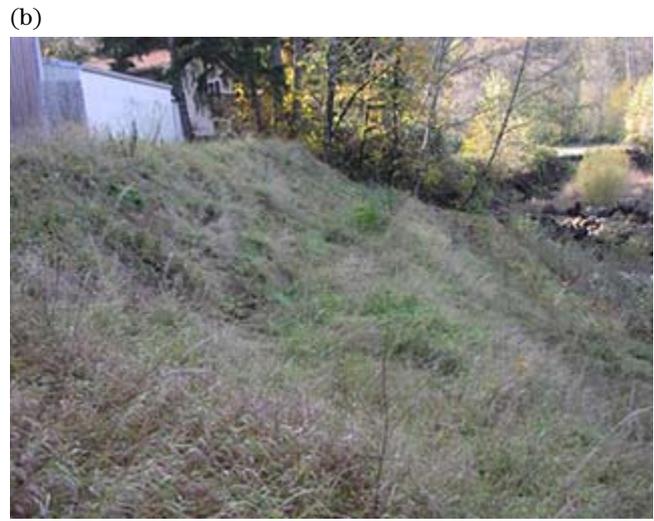
Figure CS18-25 (a) Preproject bank condition (June 2004); (b) Bank condition 1 year after project completion
