Case Study 8

**Copper Mine Brook,
Burlington, Connecticut**

Copper Mine Brook, Burlington, Connecticut

By Charles Galgowski, Design/Planning Engineer, P.E., U.S. Department of Agriculture, Natural Resources Conservation Service, Tolland, Connecticut

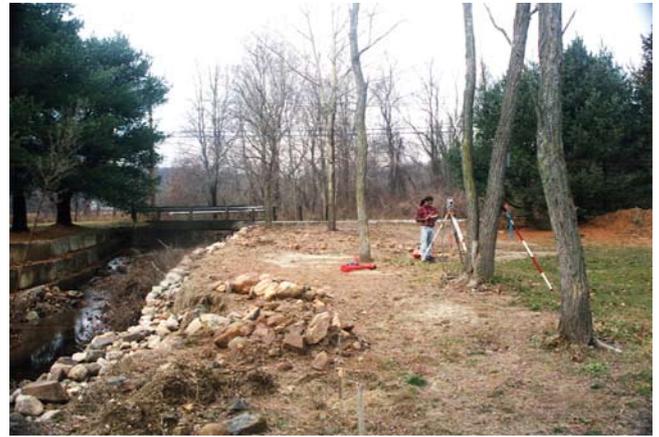
**Figure CS8-10** Site 1 before project—looking upstream at Prospect Street Bridge

The stream is incising. Stacked concrete block wall on right bank had fallen down twice before. Some rock on left bank has moved onto the flood plain.

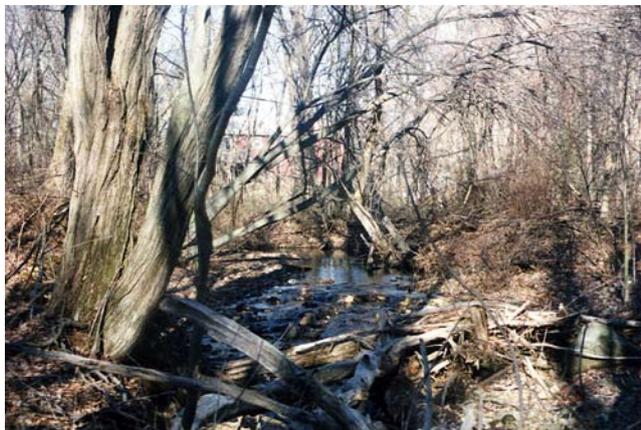
Figure CS8-9 Site 4—looking upstream at LWM waterfall

Site 4 is approximately at station 10+00 and was left unchanged during construction. The woody material created a 2-foot-high waterfall with a 2.5-foot-deep pool downstream. The woody material also helped prevent a headcut from migrating upstream. It decomposed or eroded away within 2 years of Hurricane Floyd. The brook has incised a small amount for the first 50 feet upstream. No major floods have occurred since construction.

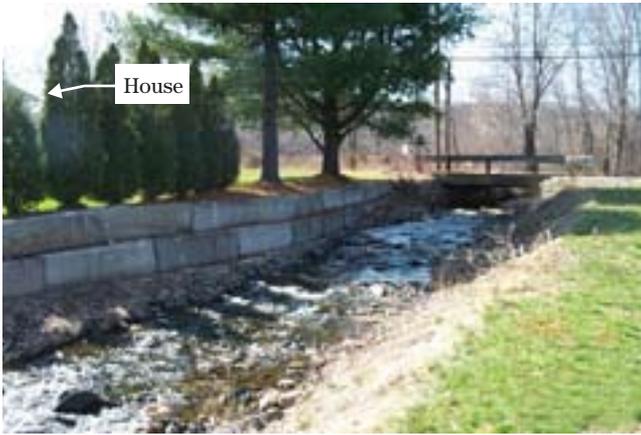
Figure CS8-11 Site 1 after project—looking upstream at Prospect Street Bridge

This photo shows the brook 2 years after construction was completed. Consequences of failure here would jeopardize the bridge and the house on the right bank, along with its septic system. The original vertical rock wall on the left bank was removed, and the bank reduced to a 2H:1V slope. The channel and bank were armored with bedding stone and riprap. Bank riprap was topsoiled and seeded to grass. The toes of both side slopes were covered with round native stone, some of which has eroded away.

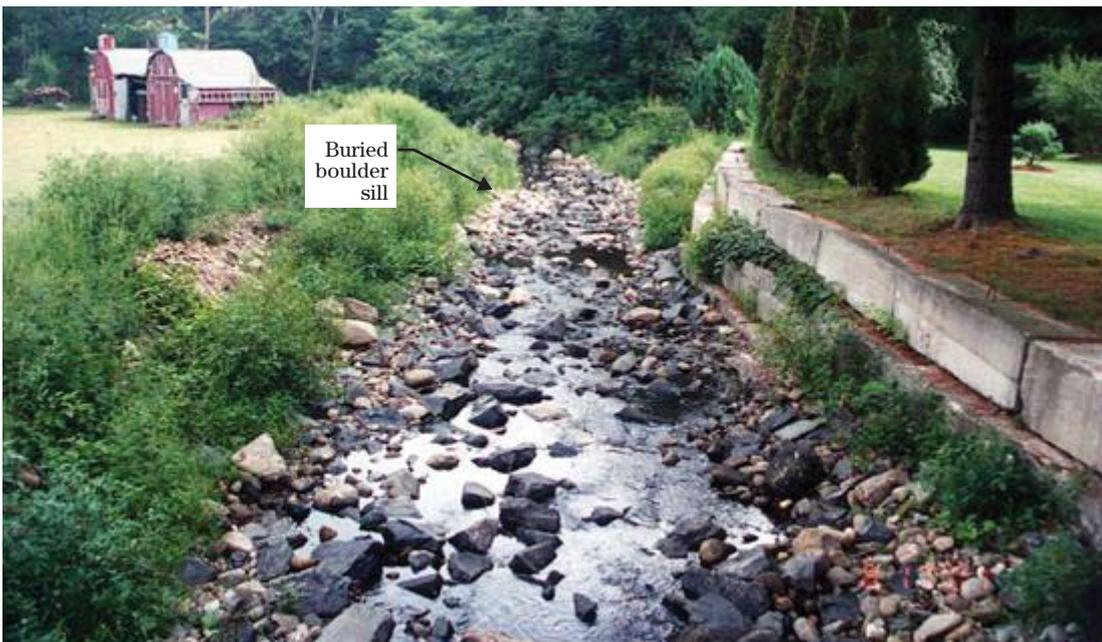
Figure CS8-12 Site 1 after project—looking downstream from Prospect Street Bridge

This photo shows the site 3 months after construction. The downstream end of the riprap terminates with a buried boulder sill. Rounded native stone was placed on both toes to help define a narrower low-flow channel and make the brook look more natural.

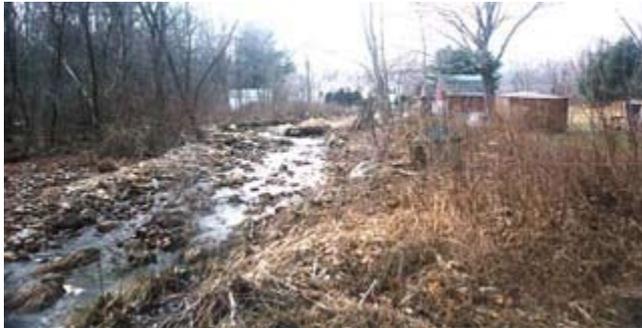
Figure CS8-13 Site 3 before project—looking upstream from station 4+50

Station 3+75 in the foreground has channel gravel and woody material over a 24-inch-diameter water main. The brook had started to carve a new channel on the right flood plain upstream at station 4+00. Existing debris or further aggradation at this site could increase flooding potential and encourage the brook to erode a new channel on the right flood plain. A head cut migrating upstream could expose the water main. The constructed project put a buried boulder sill 105 feet downstream of the pipe and removed a 0 to 2-foot depth of gravel for 175 feet of channel. Gravel removal in a wooded area downstream of this site was reduced to protect aquatic habitat.

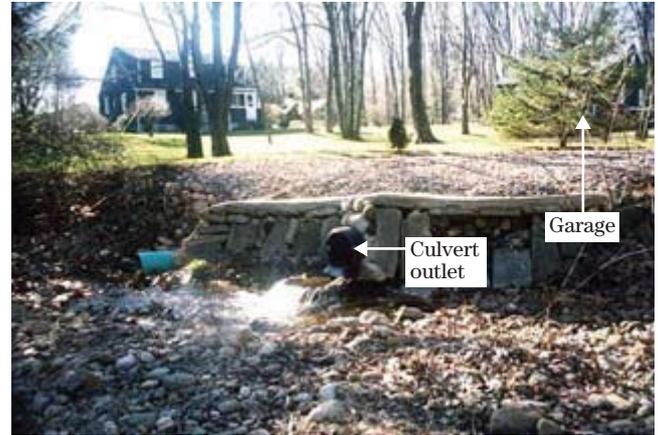
Figure CS8-14 Site 5 before project—looking at head-wall at station 11+10

During Hurricane Floyd, when floodwaters started to cut a new channel upstream at station 4+00 on the right flood plain, this downstream garage area experienced increased flooding. This 12-inch-diameter culvert was plugged with sediment when floodwater and sediment entered its inlet located behind the garage at the right of the photo.

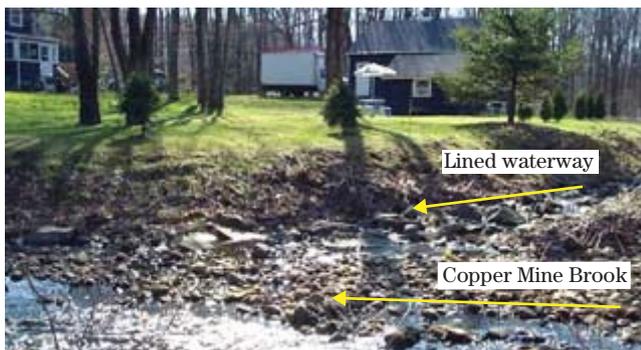
Figure CS8-15 Site 5 after project—looking at lined waterway, station 11+10

The pipe and headwall were replaced with this lined waterway entering from the right side of the photo. This was more economical than replacing the pipe and would provide much greater flood protection than a pipe. The upstream debris removal shown in figure CS8-13 had not been significant enough to remove all flooding potential here. Also, the area to the right of the lined waterway would revert to wetland plants, since the owner's access to it would be restricted with less chance of it being mowed.

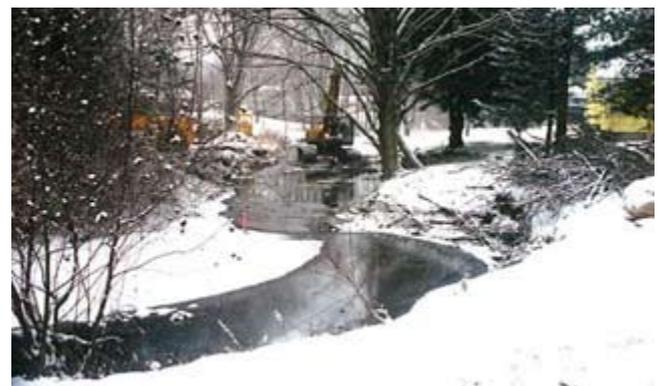
Figure CS8-16 Site 6 during construction—looking downstream at station 12+00

Hurricane Floyd eroded the bank and cut below the tree on the right. Concerns here were that the tree could fall on the house to the right. Further erosion would encroach on the lawn area and a well casing 15 feet from top of bank. This deep pool, overhanging tree roots, and riffle underneath the excavator were valued for their excellent fishing habitat.

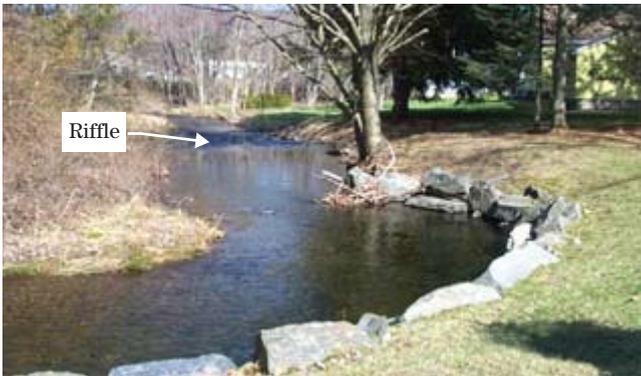
Figure CS8-17 Site 6 after construction—looking downstream at station 12+00

This is the site 2 years after construction. The angular bank-placed boulders are two boulders high into well-graded stream gravel. Lower row of boulders (mostly underwater) has 15-inch gaps for fish refugia. Cavity underneath the tree is only partially filled with boulders, providing more refugia and stability. Riffle downstream of meander was maintained. Fines have not piped out from gaps in bank-placed boulders. The site has not experienced any large floods since construction.

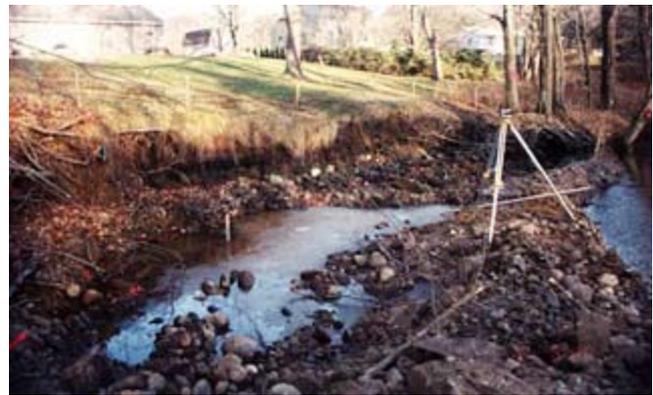
Figure CS8-18 Site 7 during construction—looking downstream at station 14+25

Survey tripod stands on the dewatering berm used during construction. Concerns here were that the brook was encroaching on the left flood plain, eroding into the lawn area and septic system and toppling trees. Area by the tree roots had deep pools and cover for fish, so saving the trees was desirable.

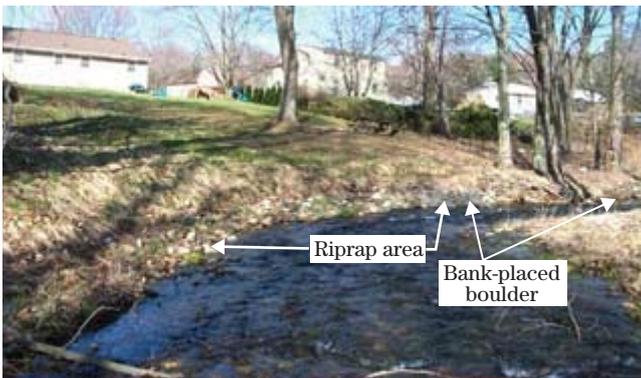
Figure CS8-19 Site 7 after construction—looking downstream at station 14+25

This photo shows site 2 years after construction. The sharp left meander is armored with bedding and riprap and covered with round native stone on the lower bank and topsoil and grass on the upper bank. The trees were protected with bank-placed boulders set into their root cavities, instead of cutting them down and placing riprap on the bank.

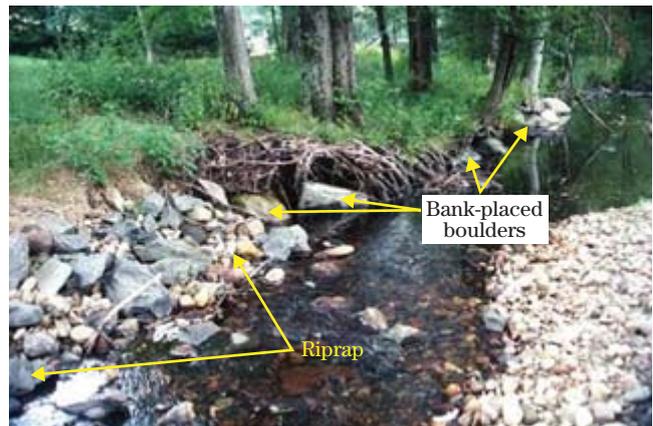
Figure CS8-20 Site 7—looking downstream at bank-placed boulders, station 14+50

This photo shows a close-up of bank-placed boulders 3 months after construction. Rounded and angular boulders were placed into the cavities of well-developed overhanging tree roots. Boulders were placed with gaps 1.5 feet apart for fish refugia. The upstream-most boulder is well protected by riprap to prevent erosion behind it.

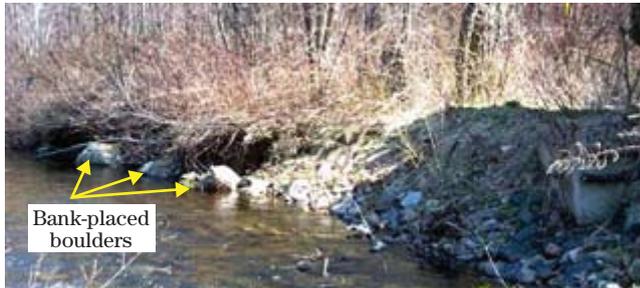
Figure CS8-21 Site 2—looking downstream at bank-placed boulders, station 2+40

- Some erosion started to occur upstream of the bank-placed boulders near station 2+40, downstream of the stacked concrete wall. The roots above and around the first boulder were not well developed, and there were no tie-back rocks.
- The bank-placed boulders located downstream at station 14+50 to 15+10 are functioning very well. They have very well-developed roots around them and stable riprap upstream.
- So far, no piping of fines has occurred around the bank-placed boulders. The site has not been

This photo taken 2 years after construction shows three boulders placed on the south (right bank) underneath overhanging roots. Concerns here were that the brook could carve a new channel into the right flood plain. The 5-foot gap between the boulders provides fish refugia. After a few months, bank erosion began to develop behind the boulder on the upstream side. This site is less stable than site 6 because there are no tieback rocks extending from the upstream bank-placed boulder back into the bank, and the root structure of the trees is smaller.
