By Sean Welch, state hydraulic engineer, U.S. Department of Agriculture, Natural Resources Conservation Service, Portland, Oregon

Introduction

The Wiley Creek Streambank Protection Project in Linn County, Oregon, was designed in 2003 and 2004 by the U.S. Department of Agriculture (USDA) Natural Resources Conservation Service (NRCS), Oregon State Office. The project goals included the protection of two structures located 5 feet from the edge of a 23-foot-high vertical bank, bank stabilization, and fisheries habitat improvement.

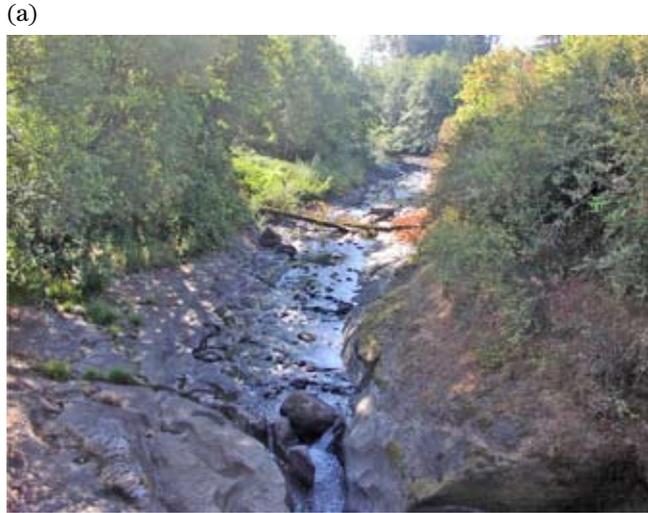
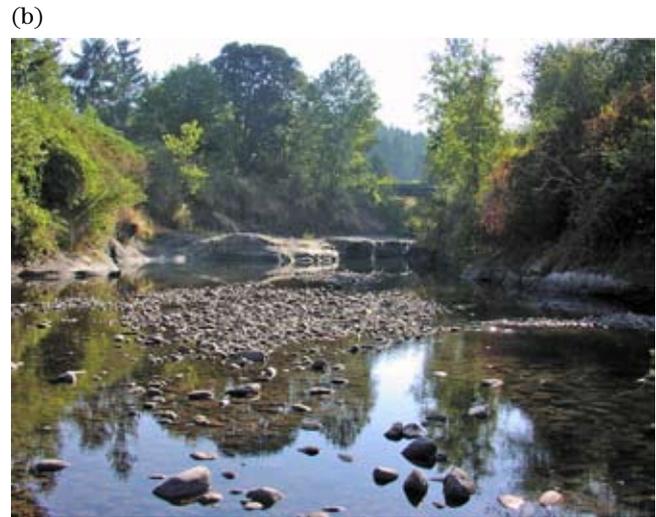
The Wiley Creek project site is located within a transitional morphologic reach of Wiley Creek. The upstream reach is narrowly confined, has low sinuosity, and is bedrock controlled. The Rosgen stream classification (Rosgen 1994) for this reach appears to be B1c. Minimal sediment deposition occurs within this reach, except for a few areas along the active channel margins. The reach is hydraulically smooth and, with the exception of a few boulders, is scoured to bedrock (fig. CS18-4).

Wiley Creek transitions abruptly from this transport-dominated reach over an 8-foot-high bedrock overfall ledge to an over-widened depositional reach. This section of Wiley Creek is adjacent to the project and is characterized by distributary flow and a large mid-channel willow dominated bar. The excessive sediment deposition in this reach resulted in an anastomosed pattern, forcing the channel against the river's left streambank adjacent to the project. This reach was classified as a Rosgen D4 stream type (Rosgen 1994) (fig. CS18-5). The project bank is located in the trees on the right side of the photo. Note the variable pattern and excessive sediment deposition. The bedrock overfall is immediately upstream, just beyond the limits of the photo.

Figure CS18-4 (a) Looking upstream from the Wiley Creek Bridge at the B1c reach above the project; (b) looking upstream to the bedrock overfall ledge. The Wiley Creek Bridge can be seen in the background. This location marked the transition from the B1c to D4 reach.

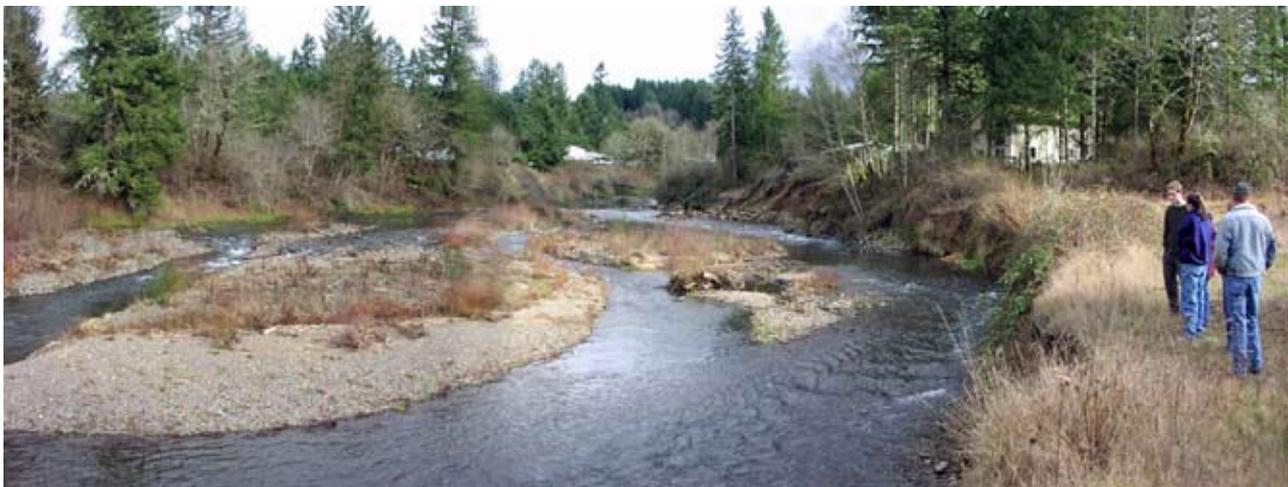
Figure CS18-5 Looking upstream at the D4 reach

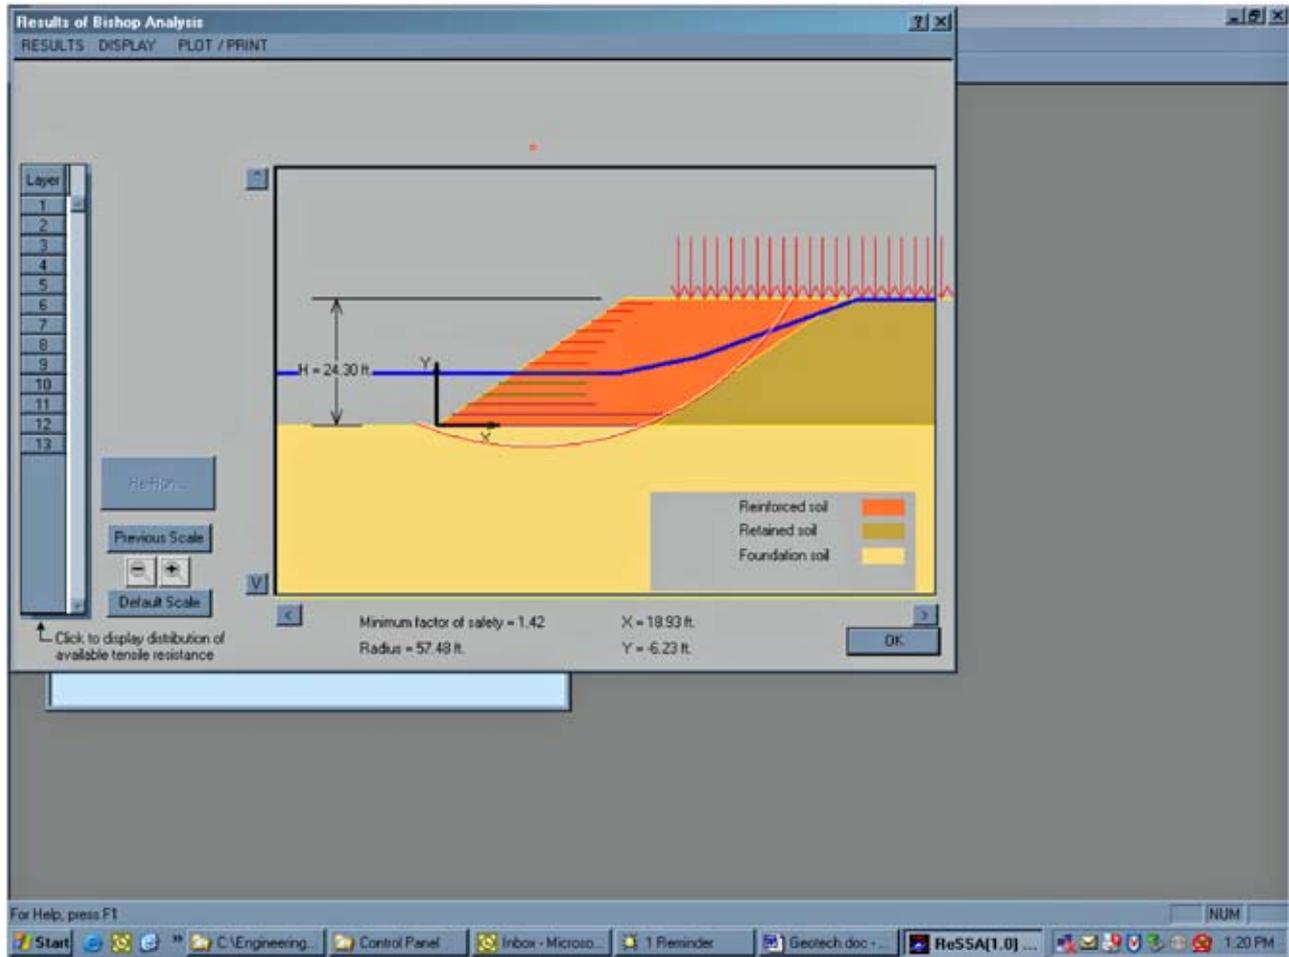
Figure CS18-11 RSSA model showing bank materials, loading, and computed tendon configuration for a mid-bank water table condition

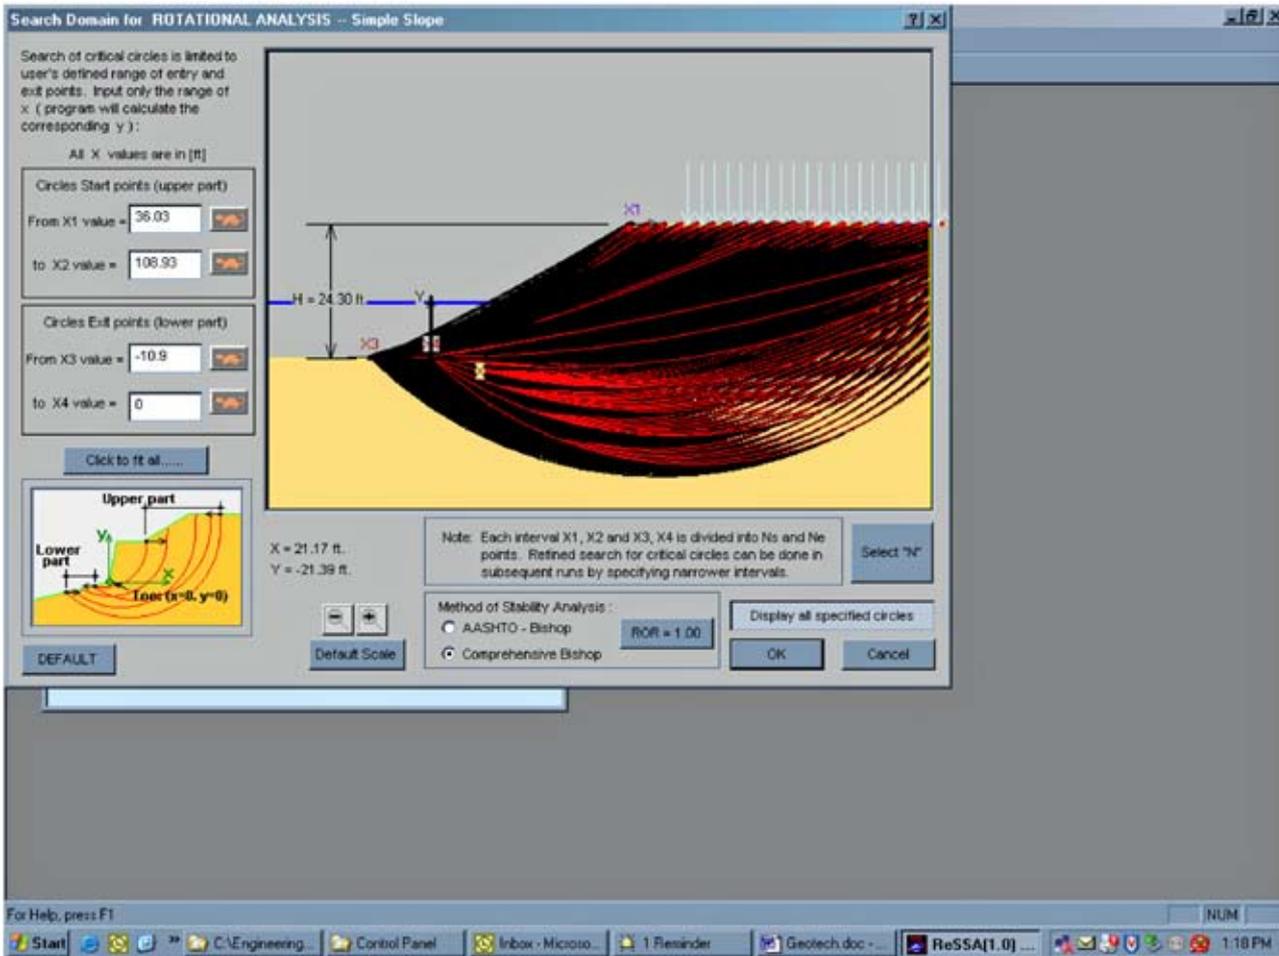
Figure CS18-12 Bishop slices showing optimization results for rotational bank failure

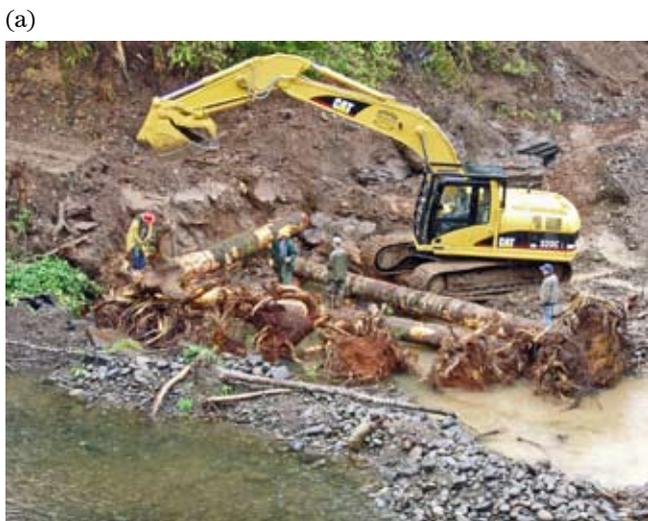
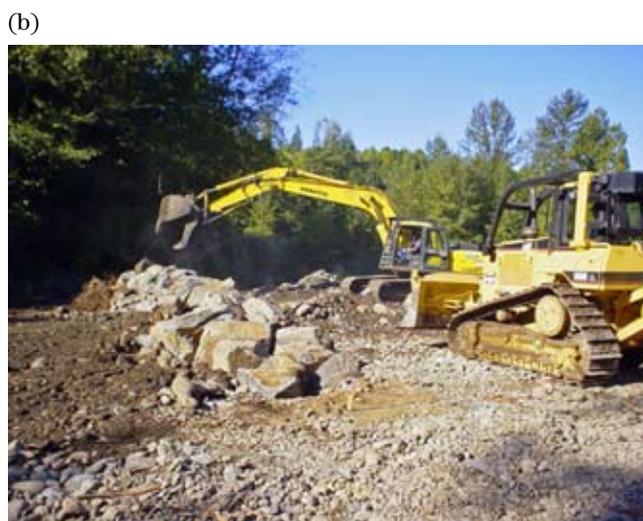
Figure CS18–14 (a) Construction of the upstream ELJ. A temporary cofferdam was placed to dewater the construction area; (b) construction of one of the project stream barbs. Photo is taken looking up the axis of the barb structure.

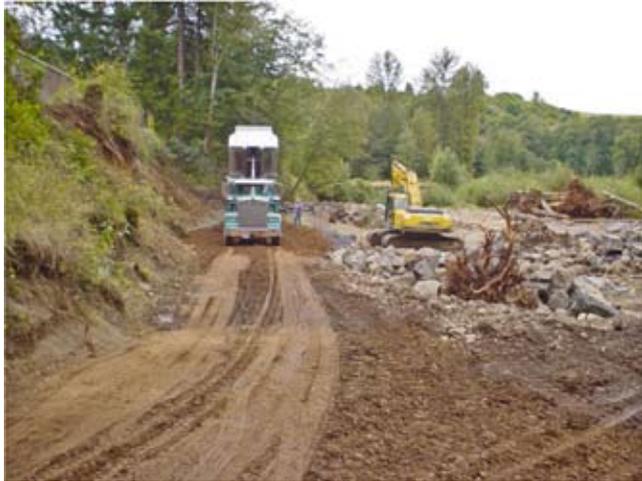
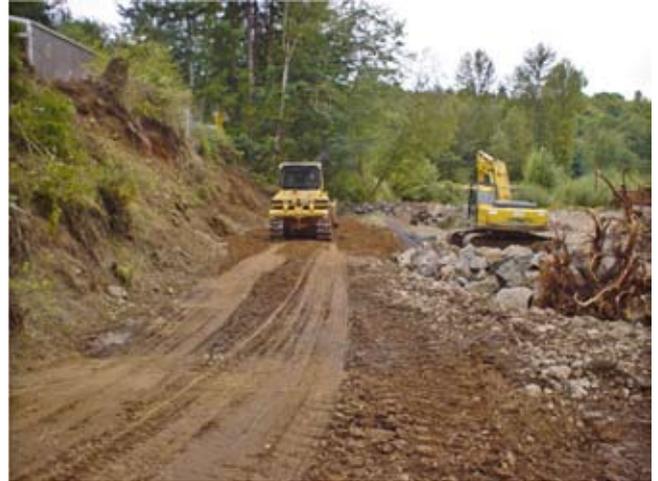
Figure CS18-17 (a) Access road was constructed to allow haul trucks to drive onto each lift, dump fill material, and provide compaction; (b) fill material was spread uniformly with a dozer.

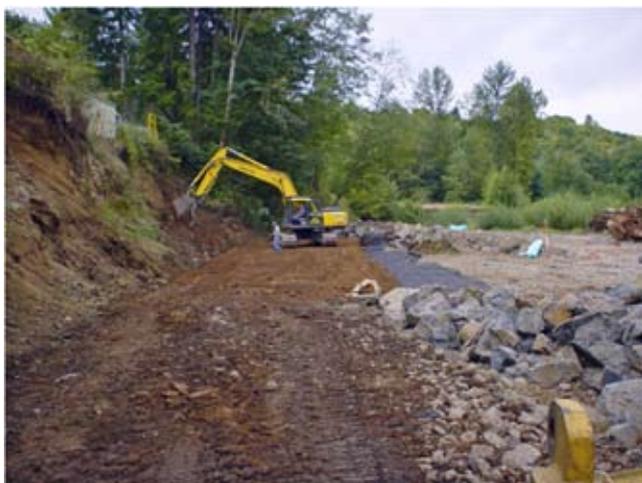
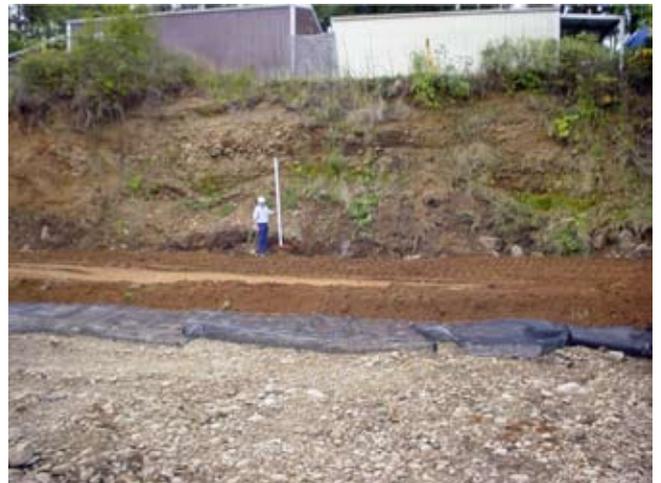
Figure CS18-18 (a) First soil lift on top of the base foundation geogrid. Portion of upstream stream barb is in foreground, and downstream barb is seen in distance. Geogrid extending from the soil is wrapped over to encapsulate the lift after compaction and grade have met specification; (b) Grade was checked at multiple locations on each soil lift. Base course geogrid can be seen underlying fill material.

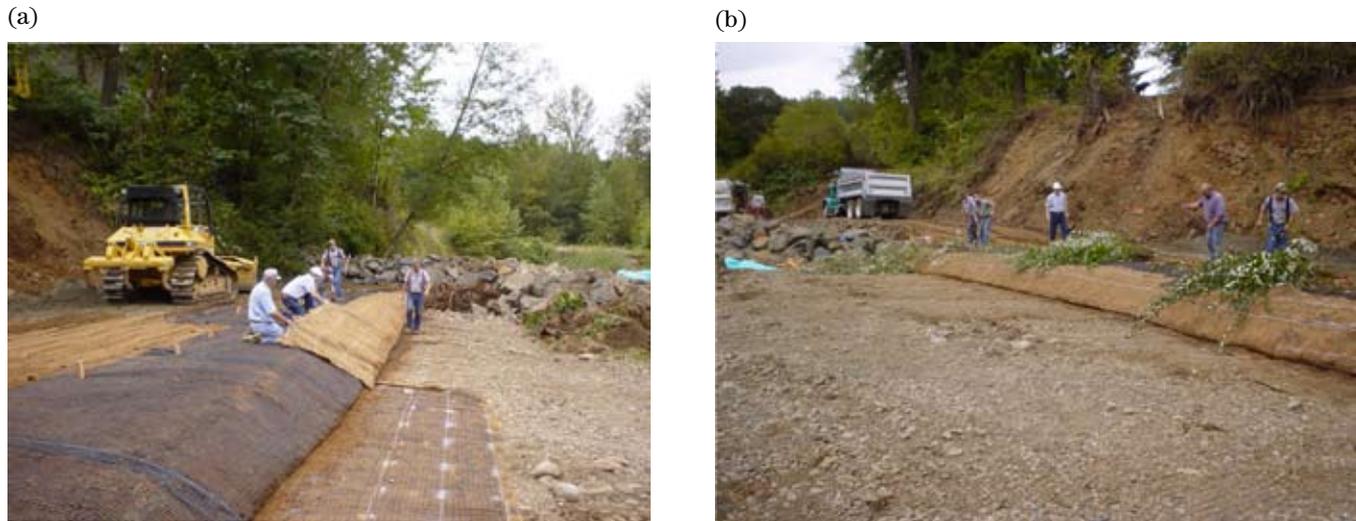
Figure CS18-19 (a) First lift is complete for grade and compaction, and geogrid has been wrapped and staked. Lift is being faced with erosion control fabric to minimize soil piping and reduce photo-degradation of the geogrid tendon. (b) First lift is completed, and willow cuttings are being placed. Willows were harvested onsite and placed between the first three lifts to the bankfull elevation.

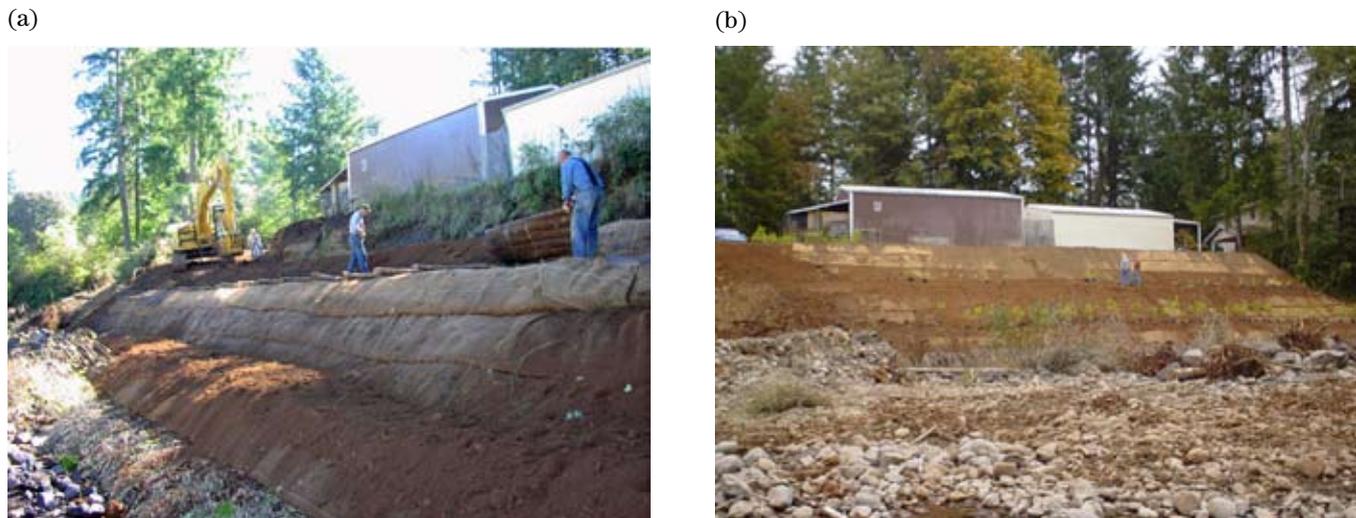
Figure CS18-20 (a) Embankment construction continues on lift #9. Note the terrace setback about midway up the bank. This feature provided a flat zone to facilitate shrub planting. Another terrace setback was placed at lift #9. (b) Embankment construction is complete and vegetation planting has started. The NRCS Plant Material Center provided guidance on native vegetation selection and appropriate species for the project.

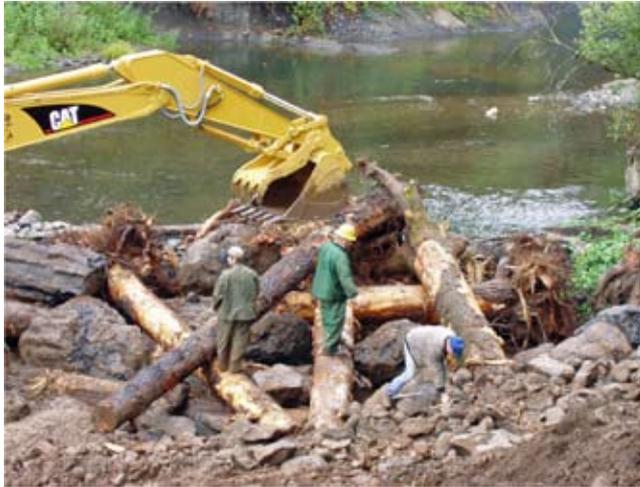
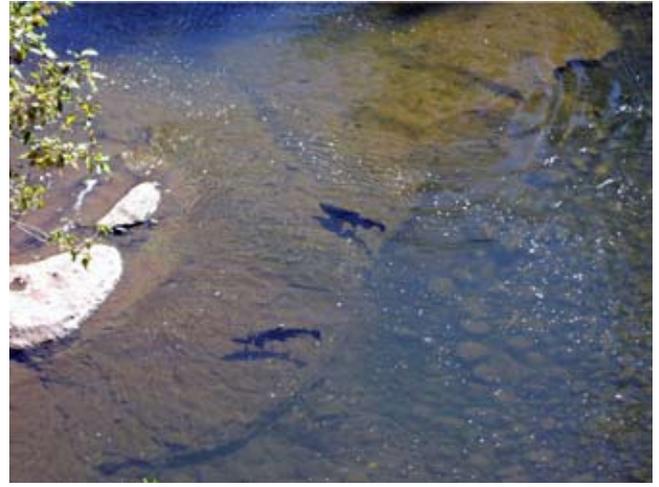
Figure CS18-21 (a) Excavator used a chain to place log members in position for the construction of the engineered log jams. Individual log members were bolted together, and rock ballast was placed. Note pool in background. (b) The presence of salmon in the immediate vicinity of the construction area required careful management of turbidity and site runoff. Photo was taken at the pool noted in figure CS18-21a.
