Case Study 8

**Copper Mine Brook,
Burlington, Connecticut**

Copper Mine Brook, Burlington, Connecticut

By Charles Galgowski, Design/Planning Engineer, P.E., U.S. Department of Agriculture, Natural Resources Conservation Service, Tolland, Connecticut

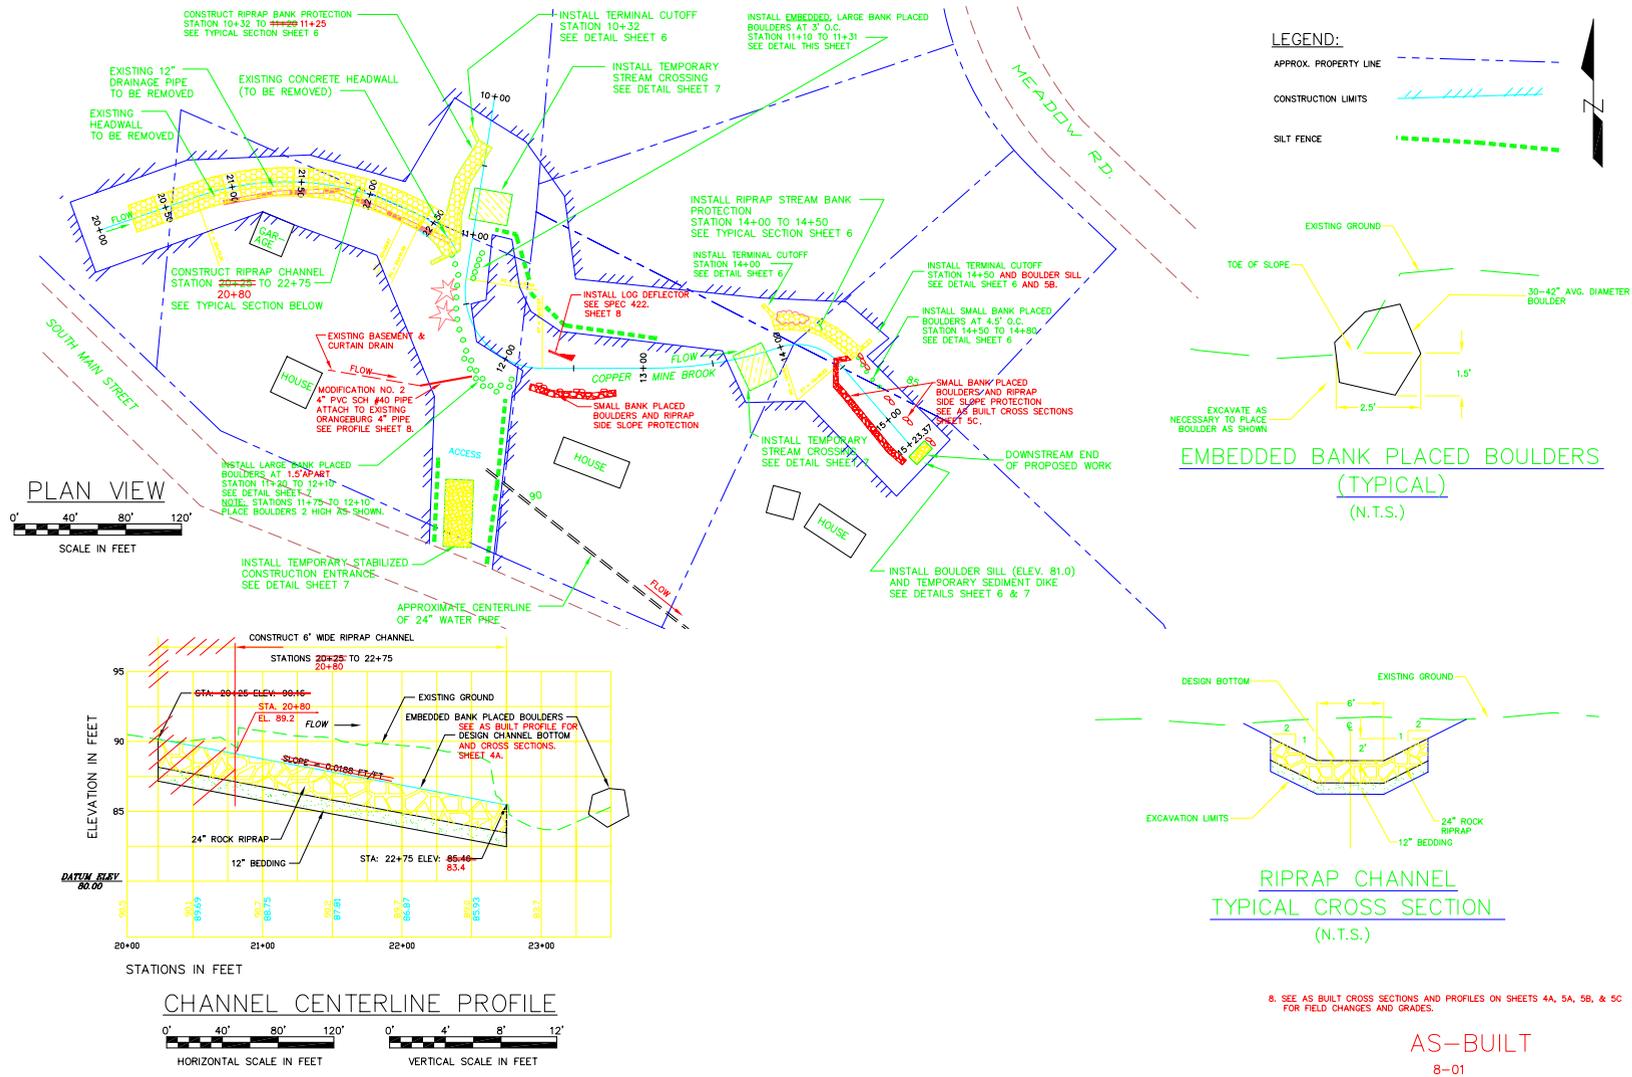
Figure CS8-7 As-built plan view starting 940 feet downstream of Prospect St.

8. SEE AS BUILT CROSS SECTIONS AND PROFILES ON SHEETS 4A, 5A, 5B, & 5C FOR FIELD CHANGES AND GRADES.
